THE SLAPTON LINE – LIVING WITH COASTAL CHANGE

ALAN DENBIGH
Slapton Line Partnership

A short article on storm damage to the Slapton Line and the threats and impacts on the local community.

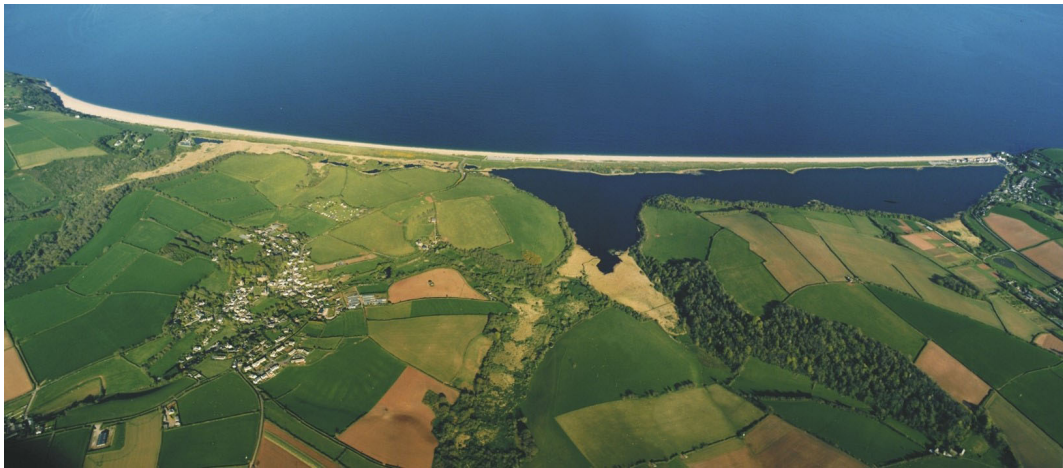
FIGURE 1. Aerial view of Slapton Ley

An aerial view of Slapton Ley (Fig.1) gives some clues to its origin: it looks as though it has been ‘dammed’ by the beach and the inland shore looks very much like a coastline. The other striking thing, is the relatively fragile nature of the thin strip of beach sandwiched between ‘Ley and sea’: possibly not the best place to build a road. To understand how we got here, we need to understand the history. First point on the journey is around 130,000 years ago. A graph of Antarctic ice core data (Fig. 2) which reveals how our climate has changed, shows a higher temperature and, with less ice at the poles, higher sea levels. Wave-cut platforms similar to those at Hallsands would have been formed, and the sea lapped on that inner western shore of what became the Ley.

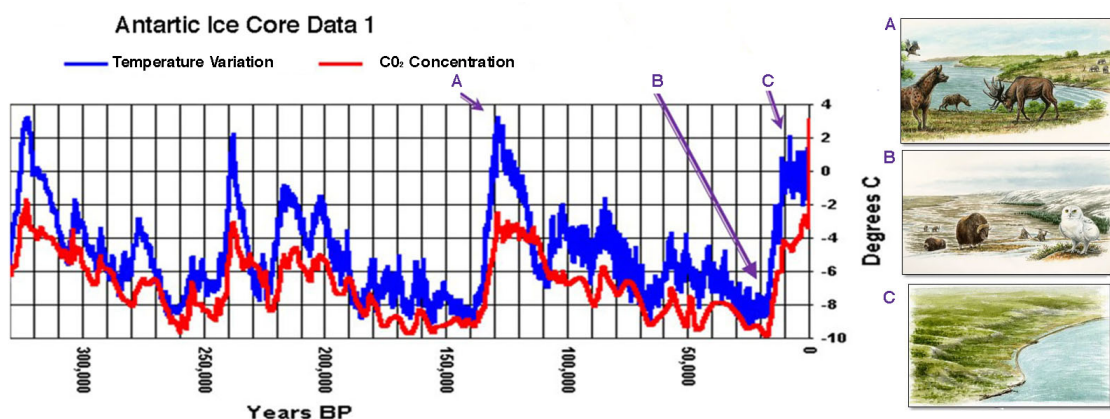
FIGURE 2. CO₂ concentration from Antarctic Ice Core Data, with corresponding temperature °C.

Moving on to the last ice age around 20,000 years ago (see B, Fig. 2). The formation of ice and colder temperatures meant that sea levels fell by around 40 metres and the coastline retreated to 20 miles from the current shore. As temperatures and sea levels started to rise again, the sea washed in a bank of shingle composed of flint and chert which have been matched with offshore deposits. The line of shingle reached Start Bay around 3,000 years ago, began to consolidate and ultimately blocked off various streams, forming freshwater lakes at Hallsands, Beesands, Slapton Sands and the marshes at Blackpool Sands.

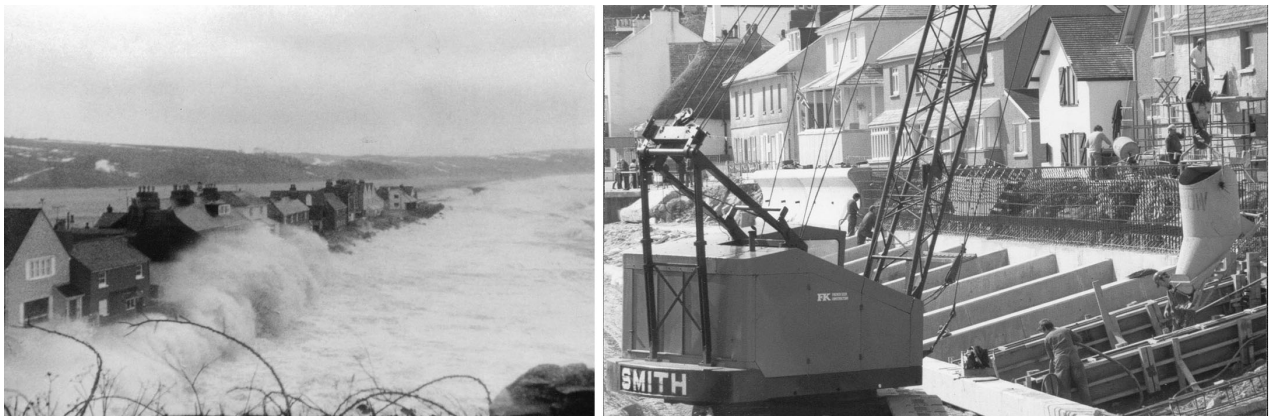
FIGURE 4. The sea wall at Torcross was built in 1979 after severe storms damaged houses. It is now being reinforced with double the depth of sheet piling in front of the existing wall (right).

Severe storms continued every ten or 20 years and, after a severe one in 1979 where waves demolished building frontages, the sea wall at Torcross (Fig. 4) was built in 1980. It is now being augmented with double the depth of sheet piling (12 m) in front of the existing wall.

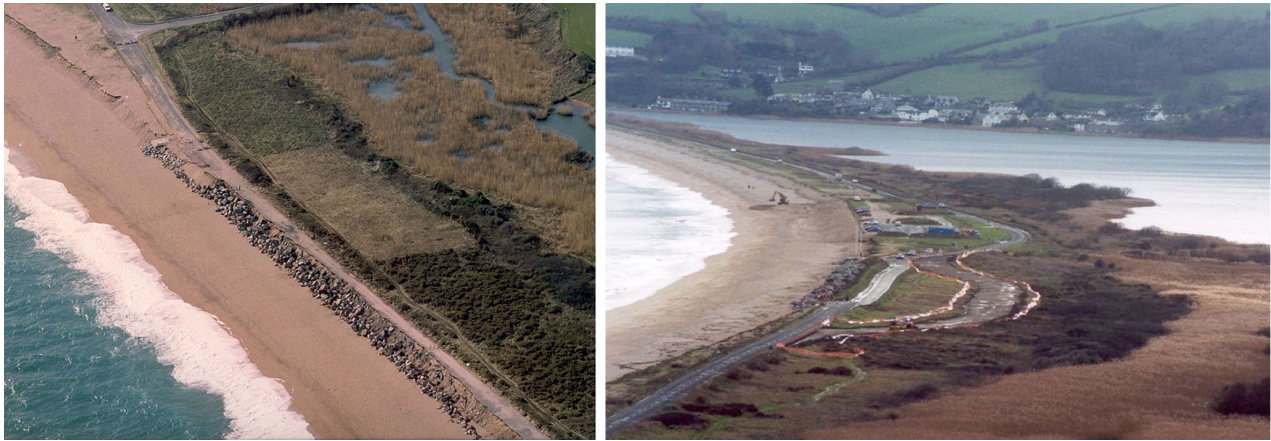
FIGURE 5. In 2001, storms undermined around 200 metres of the road along the Ley (left); it was 12 months before a new section was opened (right).

In 2001, a one-in-25 year event, with winds coming at right angles from the east onto the beach, undermined around 200 metres of road (Fig. 4). A single track road restored vehicle access, but it was 12 months before the new section was opened (Fig. 5). At this time the Slapton Line Partnership was formed, bringing together the ‘stakeholders’ with a responsibility for the road and the land, as well as the public, represented by the councillors. The Partnership helps to speed up agreement over what course of action to take in response to events, and plans future measures.

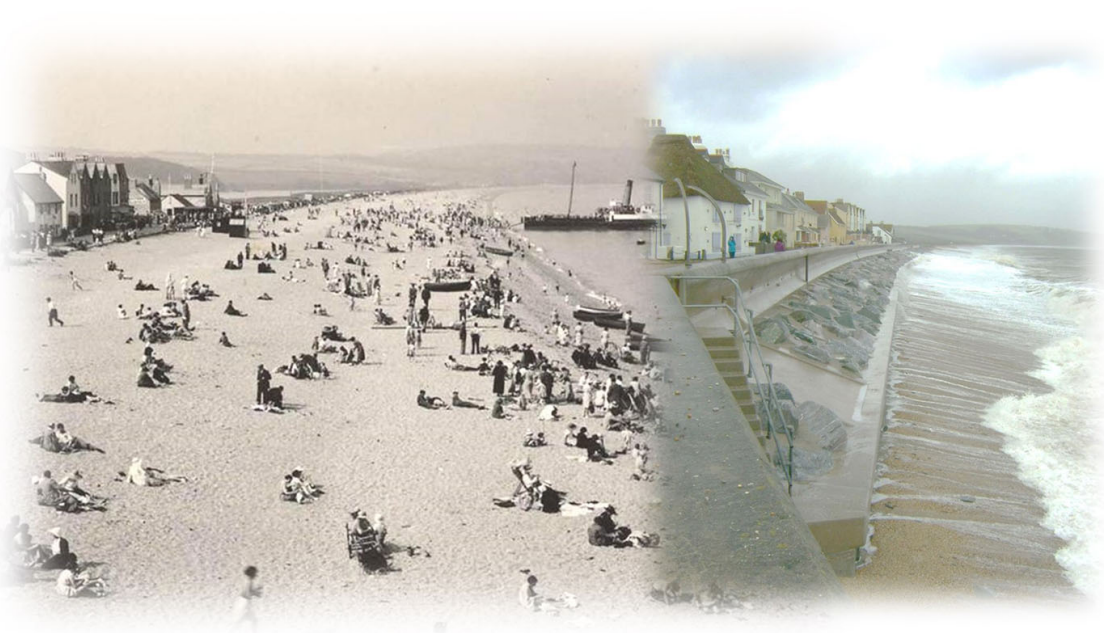
FIGURE 6. Comparison of beach levels at Torcross in 1939 (left) with present day).

In February 2014 a series of south-westerlies linked to storm Petra caused flood damage to houses at Torcross, and deposited a large amount of shingle on the road. These storms breached the railway line at Dawlish costing £35m to repair. The road got off relatively lightly, but it stripped the protective layer of shingle away from the toe of the sea wall, from much of the beach, and cut back the central car park by several metres.
