EXCEPTIONAL RAINFALL AND MUDDY FLOODING NEAR DALE FORT FIELD CENTRE, PEMBROKESHIRE, JANUARY 2024

J. BOARDMAN¹ and T.P. BURT²

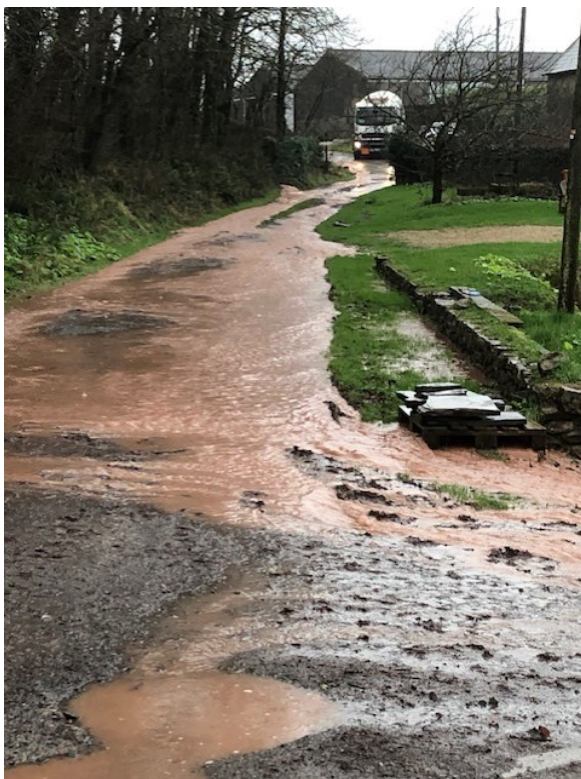
FIGURE 3. Muddy flow along track past The Grange.
Photo, Richard Neale.

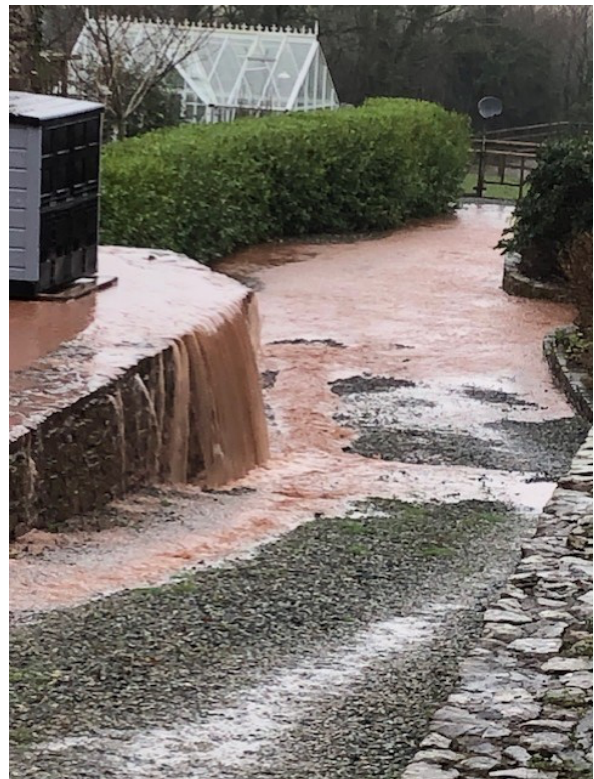
FIGURE 4. Muddy flow past The Grange and heading toward The Old Cowshed.
Photo, Richard Neale.

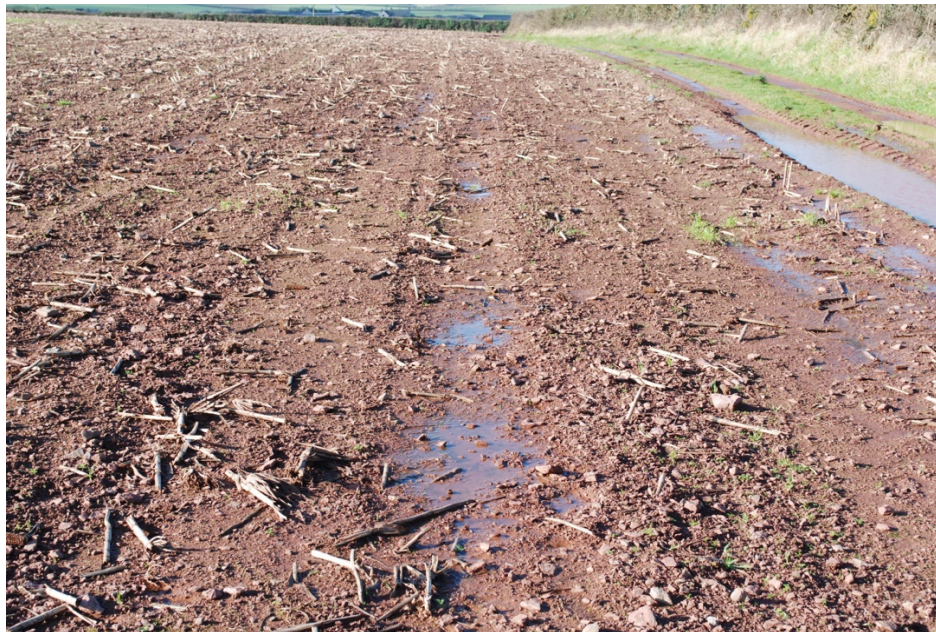
The soil in field A was briefly examined on 11 Feb (a wet day) and on 13 Feb (a dry day). Routes of runoff from the field to the open gateway were clearly visible (Figure 5). The soil is slightly stony (4.5% >2 mm) and was compacted in areas with standing water and wheelings: a fork would only penetrate to c. 10 cm. Recent rain had left the field very wet. The soil type is normally freely draining and standing water should not be present (Figure 6). The soil is slaked with a smooth surface and poor soil structure which is relatively impermeable.

Field A has debris left on the surface from the maize harvest but is largely bare (Figure 6). There were clear signs of recent runoff which exits through the gate and on to the track past the houses at Butterhill Farm (Figure 5). Most of this runoff is from Field A with a contribution from the winter cereal Field B, via the wood and onto the track opposite The Granary (Figure 2).

FIGURE 6. Field A , 11 February 2024, bare with debris from previous maize crop. Photo, John Boardman.

The risks associated with runoff from maize are twofold. In early summer, after drilling, bare ground persists for up to 3 months and is vulnerable to summer thunderstorms. In autumn, after the maize harvest, wet weather may prevent the farmer getting on the field and either establishing a cover crop or rough ploughing: bare ground will then exist for several months. The present Butterhill Farm case is of the latter variety i.e. post-harvest. As in many cases of post-harvest erosion, the desire to establish a cover crop was thwarted by wet late autumn weather which prevented work on the field. These conditions would also prevent attempts to break-up soil compaction inherited from pre-harvest and harvest working. In south-west England it is good practice to chisel plough on similar soils following maize or winter vegetables, taking advantage of any period of dry weather (Richard Smith, personal communication).

- Avoid growing maize on high-risk sites (erodible soils and sloping sites);
- Sow early maturing varieties (in order to avoid harvesting in wet autumn weather);
- Prepare seedbeds to avoid compaction and wheelings;
- Reduce post-harvest risks by establishing winter cover crop;
- Break compacted surfaces to improve infiltration;
- Rough plough after harvest if no cover crop;
- Subsoil tillage to combat compaction.

It is uncertain as to the extent of compaction in Field A. In the future, measures can and should address this issue. Maize or potatoes on Field B will also pose a risk of muddy flooding given the ease of movement of runoff through the woodland and on to the track. In both fields the establishment of grass buffer strips and winter cover crops, will reduce the risk of runoff leaving the field. The positioning of the gate at a low point in Field A is also unfortunate.

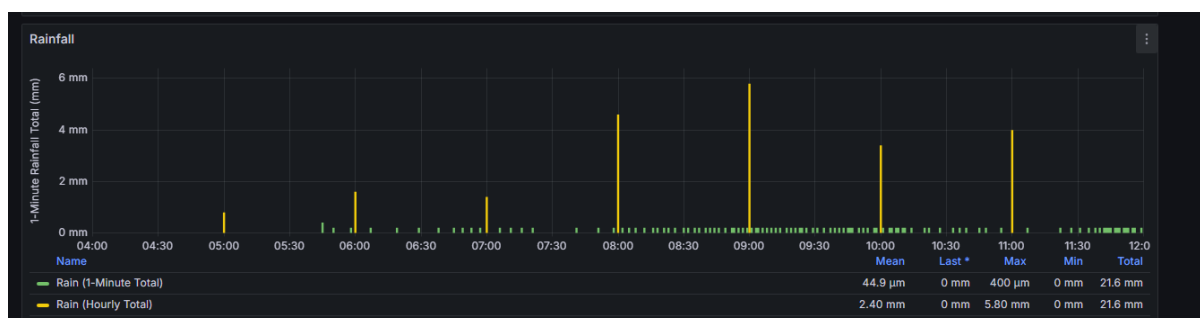
FIGURE 7. Rainfall record for 2 January 2024 for Dale Fort. The image shows a screenshot from an automatic weather station. The green lines show amounts per minute while the yellow lines show hourly totals (for the hour starting where the line is plotted).

An electronic recording rain gauge has recently been installed at Dale Fort and is run by the University of Leeds. Figure 7 is from that gauge. The hourly totals (mm) on 2 January 2024 were as follows:

05:00 - 06:00	0.8
06:00 - 07:00	1.6
07:00 - 08:00	1.4
08:00 - 09:00	4.6
09:00 - 10:00	5.8
10:00 - 11:00	3.4
11:00 - 12:00	4.0
12:00 - 13:00	1.8

Thus, a total of 23.4 mm fell in eight hours. The maximum 2-hour intensity of 9.2 mm indicates heavy rain, but not exceptionally so. We cannot be precise about the likelihood of such an event being repeated but using Figure 2.29 in Rodda *et al.* (1976) suggests a return period of less than two years. We conclude that Storm Henk produced heavy rainfall but nothing exceptional. It is worth adding that return periods are based
